TCAS II and VFR traffic

VFR traffic transponder mode and TCAS II alerts

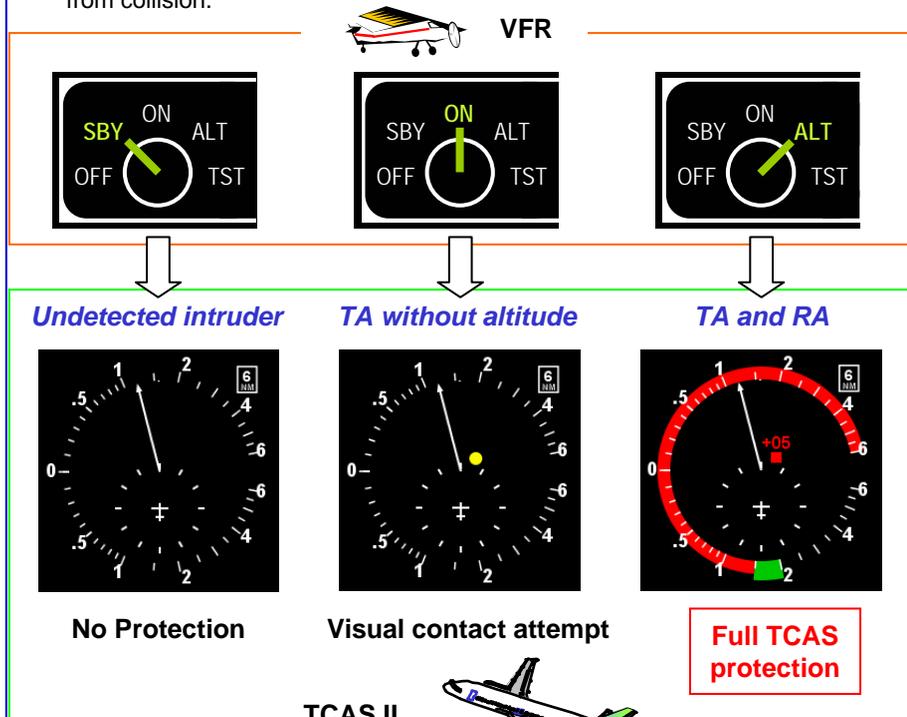
The alerts triggered by TCAS II depend on the transponder mode of the intruder.

- "OFF" or "STAND-BY": TCAS II cannot detect the intruder and therefore there is no alert at all.
- "ON", i.e. without altitude reporting: TCAS II will only generate a Traffic Advisory (TA) to help the pilot achieve visual contact. However, the TA is unable to show whether the aircraft are at the same altitude or not!
- "ALT": TCAS II can trigger TAs and Resolution Advisories (RAs). An RA, if followed, protects the VFR traffic as well as the traffic equipped with TCAS II from collision.

For maximum safety benefit from TCAS II,
VFR traffic must squawk altitude

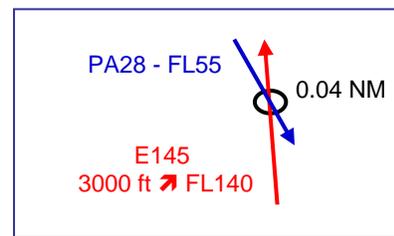
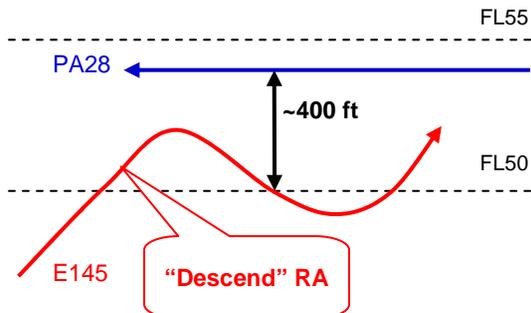
Event 1: TCAS resolution between IFR and VFR traffic in Class D

A PA28 flying VFR is transiting a TMA, in Class D airspace. It is level at FL55 (mode C reports show FL54).

An E145 is climbing on departure, on a reciprocal heading, passing 3000 ft.

The E145 is cleared to climb to FL140 by the Approach controller and "to expedite through 5500 ft due to VFR traffic at 12 o'clock, 10 NM, opposite route".

The controller also provides traffic information to the PA28 about the E145, "12 o'clock, opposite route, passing your altitude". Then, he provides further traffic information to the E145 (traffic at 12 o'clock 4 NM). About 15 seconds later, the E145 receives a "Descend" RA, when passing FL51. The pilot follows the RA correctly and initiates a descent.

As a result of following the "Descend" RA, the E145 passed about 400 ft below the PA28. Simulations indicate that **without TCAS the separation between the aircraft would have only been about 100 ft and 0.04 NM.**

Although the approved procedures appeared to have been applied, it is clear that TCAS II helped to solve a real risk of collision.

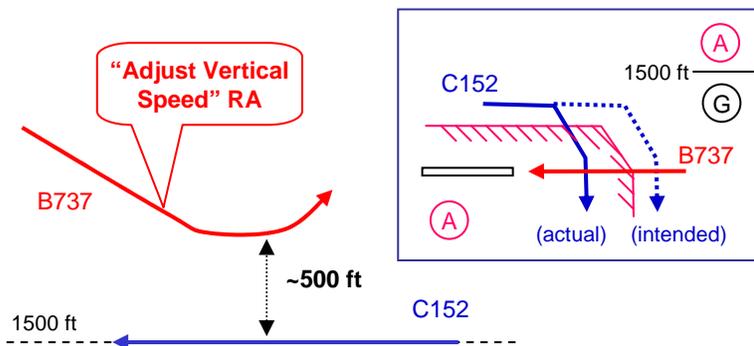
Event 2: VFR traffic penetrating Class A

In Class A airspace, a B737 is descending on the glide path for the final approach.

Due to a navigation error, a C152, flying VFR and level at 1500 ft QNH, is crossing the ILS axis at 4 NM from the runway threshold instead of at about 10 NM. The C152 has an **active altitude reporting transponder**.

The B737 pilot gets visual contact on the VFR traffic and continues the approach. As it passes through 2000 ft, the B737 receives an "Adjust Vertical Speed" RA.

In response to the RA, the pilot stops the descent and then initiates a go-around. The vertical distance between the aircraft is about 500 ft.

Simulations show that if the B737 had continued the descent, **the separation would have been less than 300 ft and 0.08 NM.**

To improve flight safety, VFR traffic should operate an altitude reporting transponder in all airspace classes, including Class G.

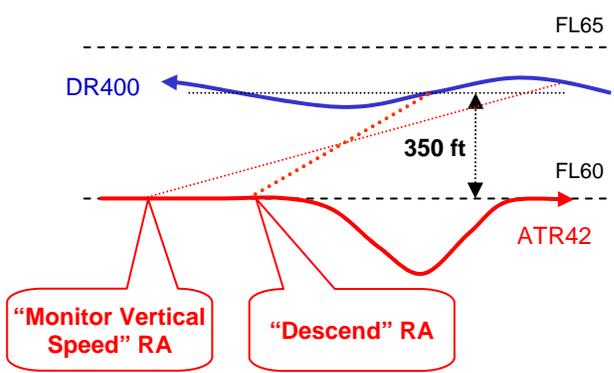
Event 3: IFR and VFR traffic crossing at 500 ft

In Class D airspace, an ATR42 is held at FL60 after departure, heading east, against a VFR DR400, on a reciprocal track, supposedly "level" at FL65.

The DR400 is not maintaining level flight and its altitude is actually **oscillating** between FL63 and FL64.

Shortly after levelling off, the ATR42 receives a **"Monitor Vertical Speed"** RA to prevent further climb when the DR400 is 2.20 NM ahead and 400 ft above.

Subsequently, the RA is strengthened into a **"Descend"** RA when the vertical separation between the aircraft becomes less than 350 ft. The pilot follows the RA and descends to FL57 before climbing back to FL60.

TCAS ensured that there was no risk of collision resulting from poor altitude keeping of the DR400.

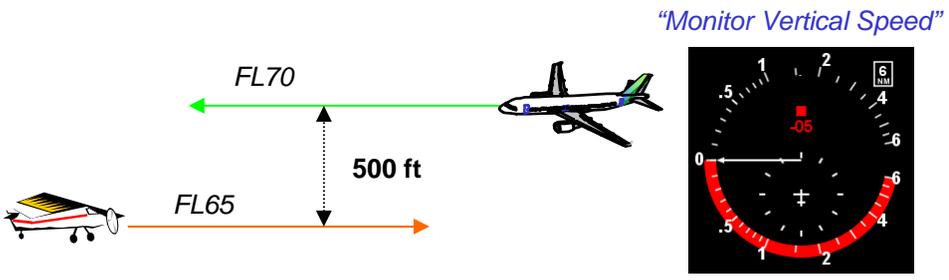
In both Class D and Class E airspaces, a frequent encounter between IFR and VFR traffic is when **both aircraft are level and "separated" by 500 ft**. In these encounters, TCAS will generate a "Monitor Vertical Speed" RA, which does not require a vertical deviation.

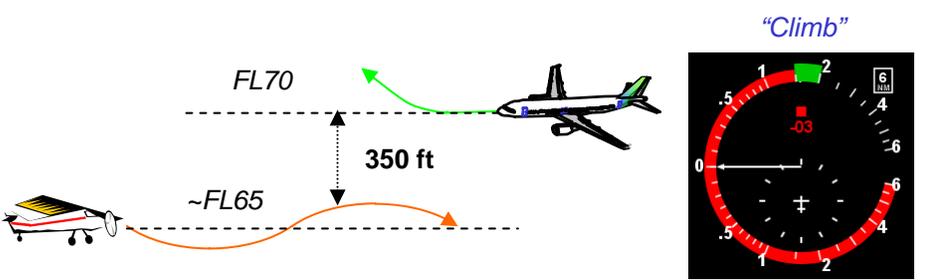
Operational experience shows that **VFR traffic sometimes do not maintain level flight perfectly**. If there is a significant vertical deviation, Climb" or "Descend" RAs will be generated on-board the TCAS-equipped aircraft.

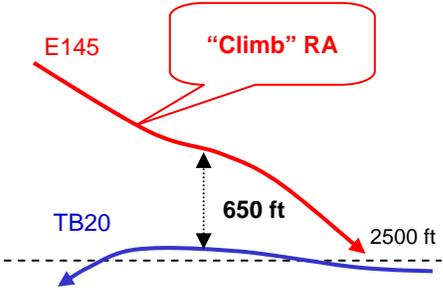
Event 4: VFR in the aerodrome traffic pattern

An E145, on approach in Class D airspace, is cleared to descend to 2800 ft QNH and to intercept the glide path.

A TB20, flying VFR and in radio contact with another controller, is crossing the runway centreline cleared at 2000 ft QNH. However, the pilot has entered the wrong altimeter setting and is actually at 2500 ft QNH.

The controller instructs the E145 to stop its descent at 3500 ft and provides a traffic information about the VFR. Because the pilot reports visual contact on the VFR, he is cleared to continue the descent on the glide path. However, the E145 then receives a "Climb" RA triggered by the TB20, which is crossing directly underneath his track.

The E145 pilot responds slowly to the RA, reducing the rate of descent. Although not achieving a rate of climb, he passes the VFR traffic at 650 ft and no more than 0.2 NM.

In this event, the high risk of collision resulting from an undetected altimeter setting error was resolved by TCAS, even though the pilot of the E145 did not achieve the vertical speed required by the RA.
