ACAS II Bulletin

May 2015 | N°18

Notable recent operational events

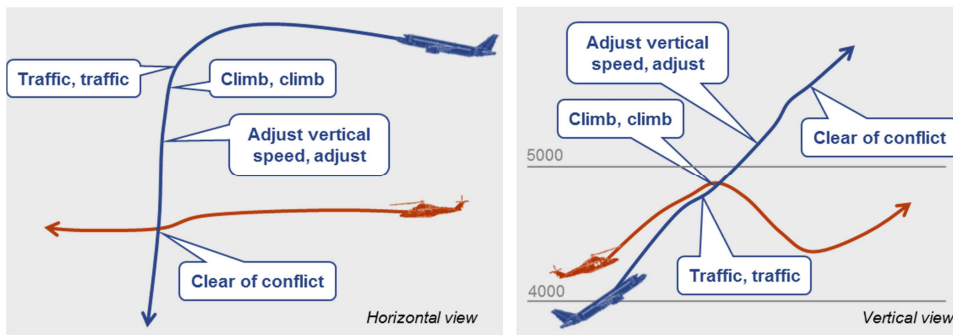
When the A320 starts its left turn, the helicopter is at its 8 o'clock position, at a distance of 1.8 NM and 230 feet above. When the A320 is turning, its vertical rate decreases from 2000 ft/min. to approximately 1000 ft/min. while the flaps are being retracted. Meanwhile, the helicopter is climbing at 1000 ft/min. The spacing between the two reduces and when they are 1.4 NM and 43 feet apart (with the helicopter still being higher), a TA is generated on the A320. The helicopter is not TCAS equipped but the crew makes visual contact with the A320, stops the climb and starts a descent to avoid the conflict.

Five seconds after the TA, the A320 gets a Climb RA. At this time the vertical rate of the A320 is 1100 ft/min., so the RA requires an increase to 1500 ft/min. The helicopter is 1.1 NM away and 25 feet below the A320. The A320 crew complies with the RA by promptly disconnecting the autopilot and increasing the vertical speed but they also continue a left turn away from the SID. After 10 seconds, the

RA weakens to Adjust Vertical Speed as the vertical spacing between the two increases to 440 feet and the helicopter is descending. After another 15 seconds, the A320 gets a Clear of Conflict annunciation when the helicopter is 1200 feet below and 0.8 NM away. At the closest point of approach the separation was 0.2 NM and 1000 feet.

Conclusions: The prompt response to the RAs by the A320 crew in combination with the *See and Avoid* manoeuvre by the helicopter crew helped to increase the vertical spacing. However, without the latter (which is a possible scenario as illustrated by Event 2) significantly less vertical spacing would have been achieved and TCAS would probably not have issued the weakening RA but would possibly even have issued a strengthening RA.

- Always follow the RA. Follow the RA even if the RA is contradictory to ATC instructions or published route (terrain awareness should be exercised at lower altitudes).
- Whilst following the RA if possible, comply with the controller's clearance, e.g. turn to intercept an airway or localizer.

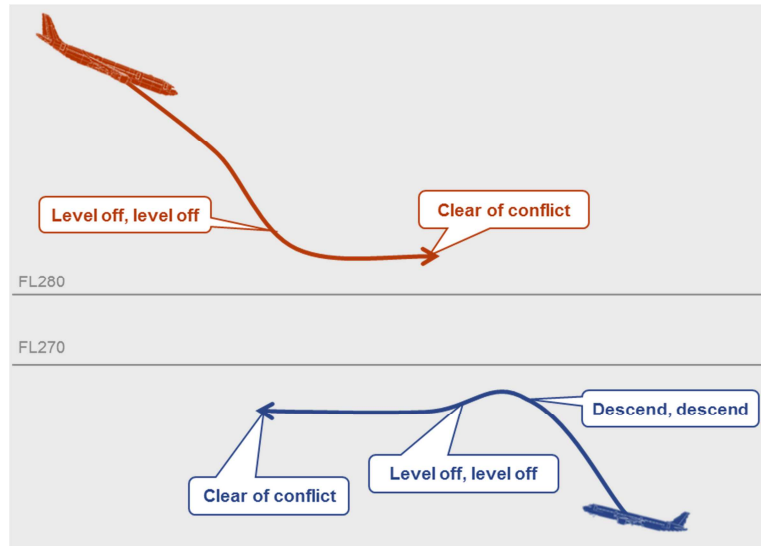
When the A330 is passing through FL320, it increases its rate of descent to 7600 ft/min. Then, the descent rate is reduced again. When the A330 is passing through FL301 at 5200 ft/min., it gets a TA against the A321 below. Simultaneously, the A321 (passing through FL261 at 2800 ft/min.) also receives a TA.

After the TA, the A330 reduces the vertical rate to 4000 ft/min. and when the A330 is passing through FL290, it receives a Level Off RA. At the same time, the A321 receives a Descend RA which weakens to Level Off after 10 seconds. Both crews respond to their RAs promptly: the A330 levels off at FL285 while the A321 levels off at FL264. Once the horizontal spacing is established, TCAS issues a Clear of Conflict annunciation and both crews receive further ATC clearances.

Conclusions: While high vertical rates provide operational benefits (in terms of fuel or time savings), aircraft climbing/descending with high vertical rates are prone to receive RAs which in hindsight would be deemed operationally unnecessary. This is because TCAS does not know aircraft intentions – autopilot or flight management system inputs are not taken into account by TCAS II – RAs are issued when TCAS calculates a risk of collision based on the closing speed and vertical rates. Sometimes, when the vertical rates are particularly high, these RAs can be generated several hundreds of feet before the cleared level. This in turn may lead to unnecessary workload for flight crews and can be disruptive for ATC.

ICAO recommends that, in order to avoid RAs in level-off situations, vertical rates are reduced to 1500 ft/min or less at least 1000 feet before your cleared level. Local or company regulations may impose different restrictions.

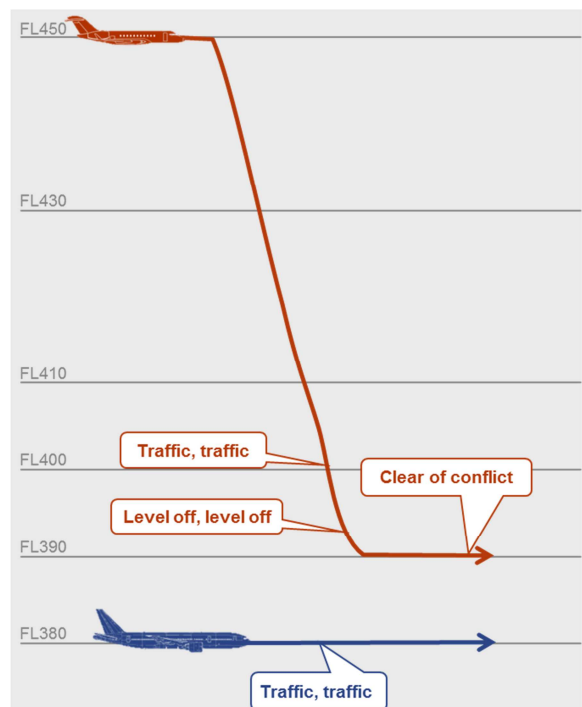
The RA was of an unusually long duration. Data collected on almost 750 RAs in core European airspace shows that the majority of RAs last 10-40 seconds (see the adjacent graph). RAs that last less than 10 seconds or significantly longer than 40 seconds are not common but they can occur in some geometries.

In the encounter described above the two aircraft were flying on the same track, at nearly the same speed, in level flight and virtually one above the other. That prevented the RA termination because one of the internal TCAS tests was continuously satisfied in this geometry. The RA was allowed to terminate only when the B777 changed its heading. Also, a change in a speed of either of the aircraft could have caused the RA termination as well.

Although the majority of RAs will last between 10 and 40 seconds, short or long duration RAs may occasionally occur in some geometries.
