# SAFETY FLASH ACAS II bulletin No 7

## The Dos and Don'ts of TCAS II Operations

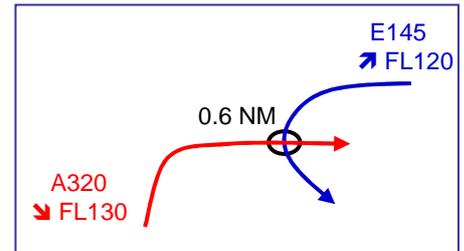
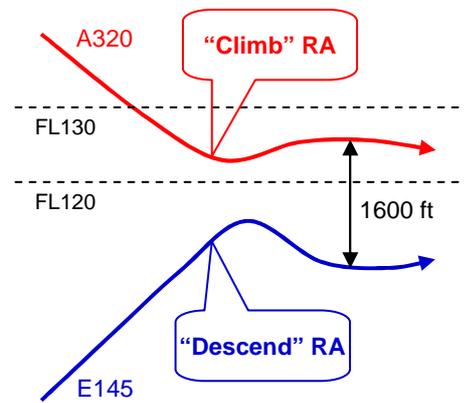
After the level bust by the A320, the TCAS II of each aircraft triggers a coordinated RA which is correctly followed by the pilots:

- the E145 receives a "Descend" RA when passing FL113
- the A320 receives a "Climb" RA when passing FL122

At the same time, a Short Term Conflict Alert is triggered. The controller who is not aware of any RA, instructs the A320 to climb back to FL130 and the E145 to descend to FL110. The A320 pilot reports that they are already following a "Climb" RA. In this case, the ATC instructions happened to be compatible with the RAs.

**TCAS II acted perfectly as an efficient safety net for preventing mid-air collision** between aircraft. It detected the unsafe situation (one aircraft climbing and the other descending to the same flight level) and generated a coordinated RA to resolve it. The response by both pilots provided a safe vertical separation.

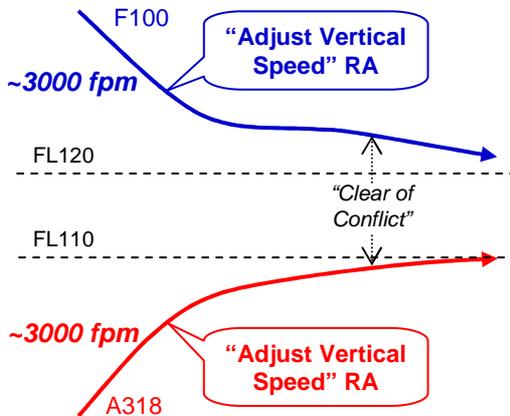
An A318 is climbing to FL110 at about 3000 fpm. A Fokker 100 is descending to FL120, also at about 3000 fpm.

The aircraft trajectories are converging both horizontally and vertically. Due to the high vertical closure rate (6000 fpm), the A318 and the F100 receive an "Adjust Vertical Speed" RA at respectively 900 and 1000 ft from their cleared flight level. Both RAs request to reduce the vertical speed to 1000 fpm.

- The A318's pilot reduces the rate of climb to less than 1000 fpm.
- The F100's pilot first stops the descent and then descends again at about 1000 fpm.

The correct reactions to the RAs by both pilots minimised the impact on ATC.

TCAS II version 7 contributed to a significant reduction in the number of RAs generated when aircraft are expected to level-off to achieve 1000 ft separation. However, these situations still cause a large majority of RAs. Recent figures from a major European airline show that they represent 70% of RAs generated on its A320 fleet.

The [ACAS Bulletin n°2](#) describes some solutions to reduce the number of these RAs. Some progress has been made regarding the reduction of the vertical rate approaching the cleared flight level.

Several airlines have modified their standard operating procedures to require the pilots to reduce the vertical rate to less than 1500 fpm within the last 1000 ft before cleared flight level (usually, when the pilot is aware of an aircraft at the adjacent flight level). Data collected by a major European airline show that the likelihood of receiving an RA while levelling off is three times lower when this reduction is implemented.

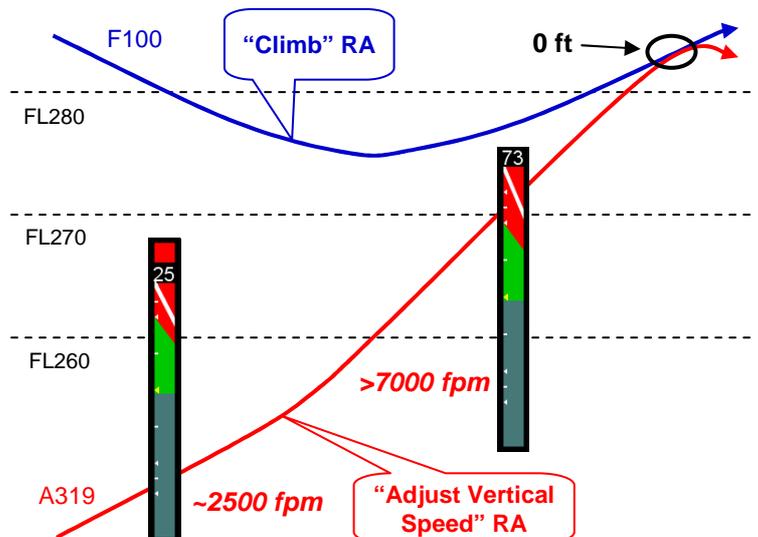
An A319 is climbing to FL260 at about 2500 fpm.

When passing through FL251, it receives an "Adjust Vertical Speed" RA requiring a reduction in the rate of climb to 1000 fpm. The RA is triggered against a Fokker 100 descending to FL270 at 2000 fpm on a converging track.

The A319's flight crew misinterprets the RA and increases the rate of climb to more than 7000 fpm instead of reducing it. Due to this opposite reaction to the RA and despite a correct response of the Fokker 100 to the coordinated RAs ("Adjust Vertical Speed" then "Climb"), the A319 receives a strengthened "Descend" RA. However, the flight crew continues to climb very quickly until the "Clear of Conflict".

As a result, the A319 busts its cleared flight level by 2200 ft and the aircraft passed at a distance of 1.6 NM at the same altitude.

The safety issue of opposite reactions to "Adjust Vertical Speed" RAs whereby pilots believe that they are reacting appropriately was described in detail in the [ACAS Bulletin n°3](#). The event above illustrates that such events continue to occur. Due to the severity of this issue, there are several on-going actions to address it, including pilot's training and TCAS II specifications.

- Some airlines have adapted their TCAS II training programmes with respect to this issue. The main objective is to explain clearly to pilots that when an "Adjust Vertical Speed" RA is triggered by TCAS II, the required action is always to **"REDUCE VERTICAL SPEED"**. This enhanced training has contributed in the reduction of the number of occurrences but has not fully eradicated the problem.
- RTCA, the TCAS II standardisation body, is investigating this safety issue and the causes for such opposite reactions have been identified in a recently published report. The work is going on to improve the aural message and the display for these specific RAs. EUROCONTROL, in support of RTCA work, is investigating a possible modification of the "Adjust Vertical Speed, Adjust" aural annunciation, together with a simplification of the TCAS II RA list.

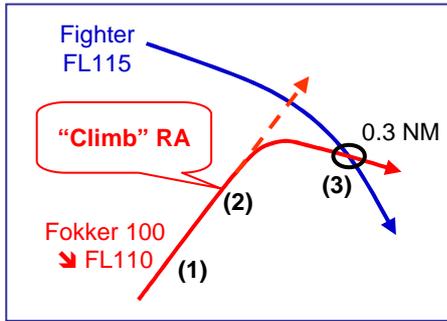
A Fokker 100 is descending to FL110. Its TCAS triggers a "Traffic Advisory" and then a "Climb" RA when passing FL130, against a fighter at FL115. The pilot correctly follows the RA and starts to climb.

However, the pilot also initiates a 70-degree right turn based on the TCAS traffic display which shows the intruder on the left. The climb provides a safe vertical separation (more than 1000 ft) whereas **the right turn actually reduces the horizontal separation** from 1 NM to 0.3 NM.

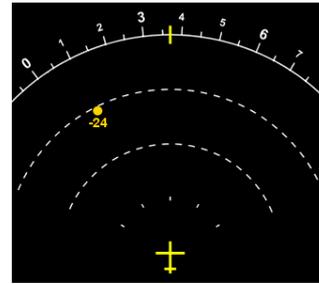
(1) "Traffic, Traffic"

Due to the relative motion of the symbol and the lack of speed vector on the TCAS traffic display, the flight crew incorrectly interpreted that the intruder was converging towards the own aircraft from the left under a bearing of 30°. However, the ground track angle was about 90° as shown on the figure.

The display shows only a partial traffic picture, shows no history or past position and has no speed vector for intruders.

It has a moving reference: as the aircraft itself is moving, the displacement of the intruder's symbol does not correspond to the intruder's actual ground track.

The bearing of the intruder's symbol has limited accuracy.

Therefore, pilots must only use it according to its intended function: to assist the visual acquisition of surrounding aircraft.

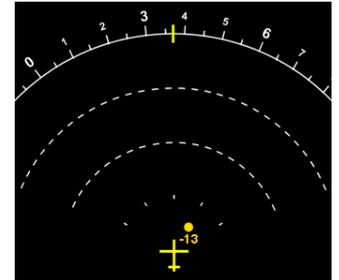
Projected fighter position if no turn executed

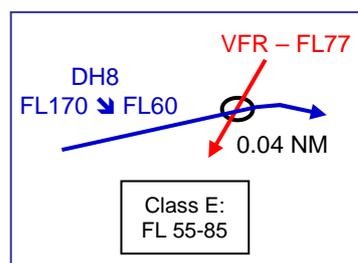
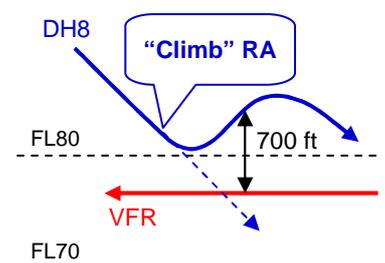
A DH8, flying IFR, is descending to FL60. When approaching FL80, it receives a "Climb" RA. The pilot stops the descent and climbs back about 400 ft. The intruder is an uncontrolled altitude transponding VFR aircraft cruising at FL77.

The VFR was flying in class E TMA in radio contact with FIS. The vertical limits of this class E airspace range from FL55 to FL85.

The pilot's reaction to the "Climb" RA enabled the DH8 to pass 700 ft above the VFR. Simulations indicate that without TCAS, the minimum separation between the aircraft **would have only been less than 150 ft and 0.04 NM**.

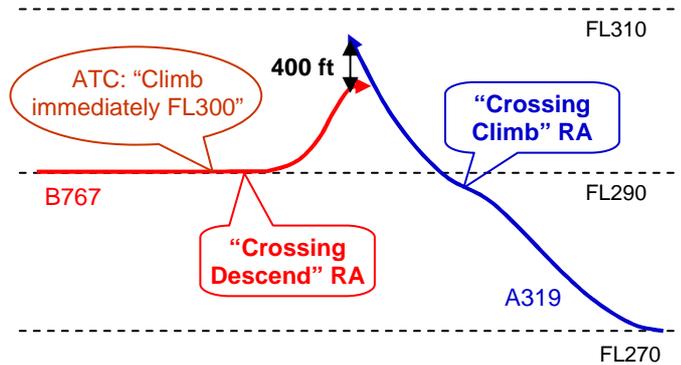
A B767 is maintaining FL290 heading West. An A319, heading South-East, is at FL270 on a converging track. The aircraft are controlled by two different ATC units (the vertical boundary is FL285).

The A319's pilot requests for a higher cruising level. Due to a coordination error between the two ATC units, the A319 is cleared to climb to FL290 with the B767 whilst in conflict.

Following Short Term Conflict Alerts triggered in both ATC units, **the B767 is instructed to climb immediately to FL300** and the A319 to "expedite descend FL270".

However, almost at the same time, each aircraft receives a coordinated RA opposite to the ATC instruction.

- The B767 receives a "Crossing Descend" RA. **The pilot disregards the RA and follows the ATC instruction to climb.**
- The A319 receives a "Crossing Climb" RA. The pilot correctly reacts to the RA by increasing the rate of climb.

Because of the B767 pilot's opposite manoeuvre to the RA, the very small vertical separation between the aircraft does not increase. Consequently, the A319 receives an "Increase Climb" RA and the pilot increases the rate of climb to 5000 fpm. The B767's pilot eventually recognises the "Descend" RA and stops the climb just before the "Clear of Conflict".

Despite the large vertical deviation of the A319 (3000 ft), the aircraft passed at **400 ft and 0.3 NM**.

Previously, the ICAO regulation was not sufficiently explicit. Therefore, ICAO revised the ACAS procedures and pilot training guidelines to require pilots to follow all RAs. The ICAO PANS-OPS Doc 8168 was updated in November 2003 and as described in the ACAS Bulletin n°5, the ACAS procedure now clearly states that:

**"Pilots shall respond immediately by following the RA as indicated, unless doing so would jeopardise the safety of the aeroplane"**

However, Event 6 shows that there are still some pilots who do not follow RAs, and who even manoeuvre in the opposite sense of the RA, whereas the ICAO PANS-OPS Doc 8168 also states that:

**"Pilots shall not manoeuvre in the opposite sense of an RA"**
